FORD:

2011-2015 Explorer

This article supersedes TSB **16-0165** to add a causal basic part number and condition code.

ISSUE

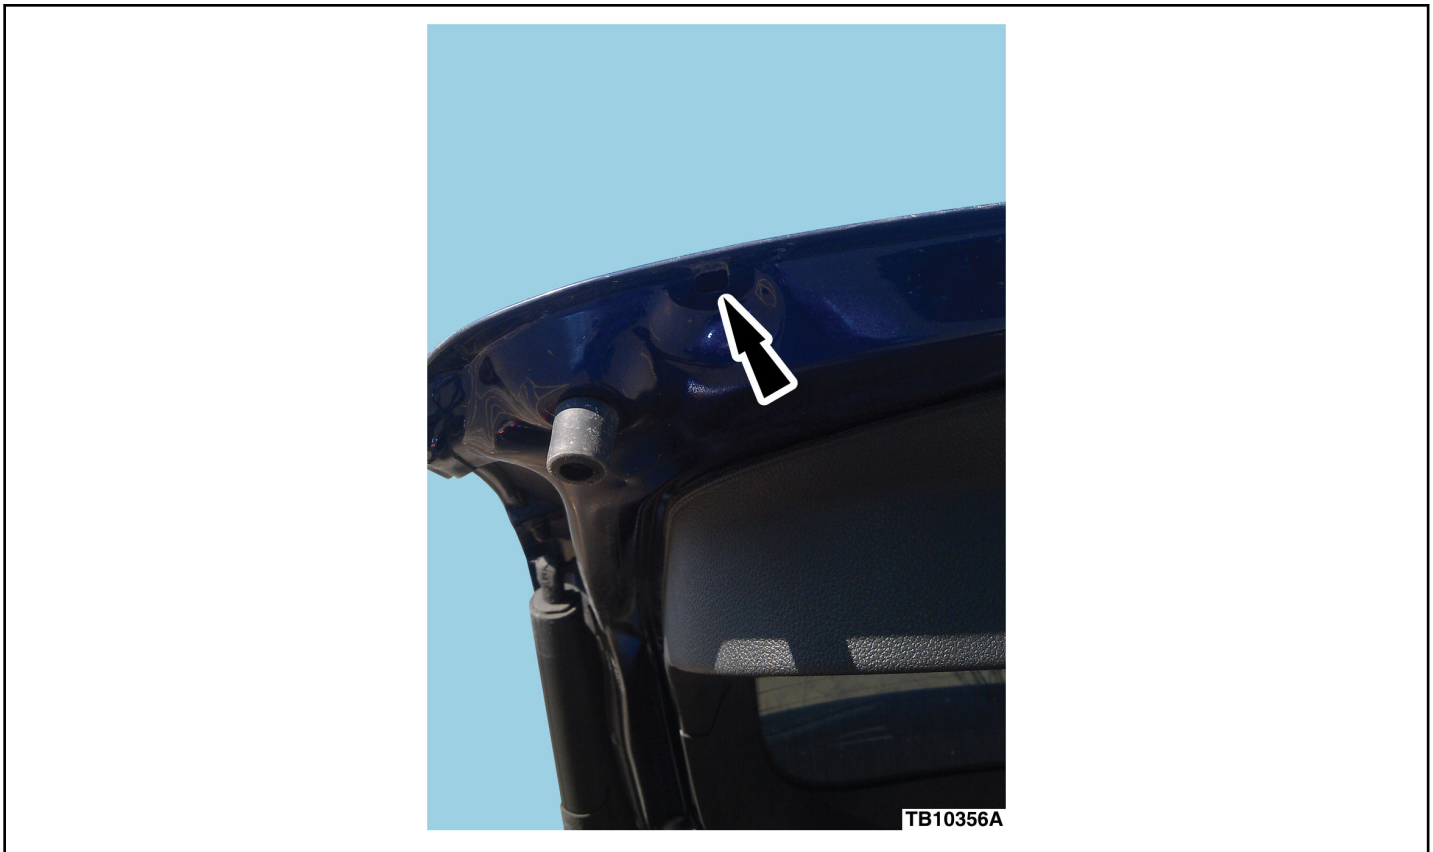
Figure 1 - Article 16-0166

1. Reprogram the heating ventilation air conditioning (HVAC) module to the latest calibration using IDS release 101.03 or higher. Make sure you are connected to the internet when entering module programming to obtain the latest updates. Calibration files may also be obtained at www.motorcraftservice.com.
 - a. When reprogramming the HVAC, IDS will have additional questions which will require a yes response to reprogram the module.
2. Remove the rear bumper cover. Refer to Workshop Manual (WSM), Section 501-19.
3. Remove the left and right tail lamps. Refer to WSM, Section 417-01.
4. Remove the wheel lip mouldings. Refer to WSM, Section 501-08.
5. Open the liftgate and inspect for presence of drain valves in the two (2) drain holes on the left and right side of the liftgate. Are the drain valves present? (Figure 1)

- a. Yes - proceed to Step 7.
 - b. No - proceed to Step 6.
6. Install a new drain valve in each of the two (2) drain holes on the left and right side of the liftgate. (Figure 1)
 7. Inspect the liftgate seal for damage and proper fit/contact pattern. Adjusting the rear liftgate striker so that the rear hatch seals tighter to the liftgate seal is important. This can be done by loosening the striker and moving it to increase the liftgate sealing pressure.
 8. Inspect the left and right side air extractors for proper fit to the body and operation/sealing of the rubber flaps.
 - a. Replace the air extractor if it is warped or damaged or flaps do not lay flush to their sealing surface. (Figure 2)
